PIC18F85J11 Family Silicon Errata and Data Sheet Clarification

The PIC18F85J11 family devices that you have received conform functionally to the current Device Data Sheet (DS39774D), except for the anomalies described in this document.

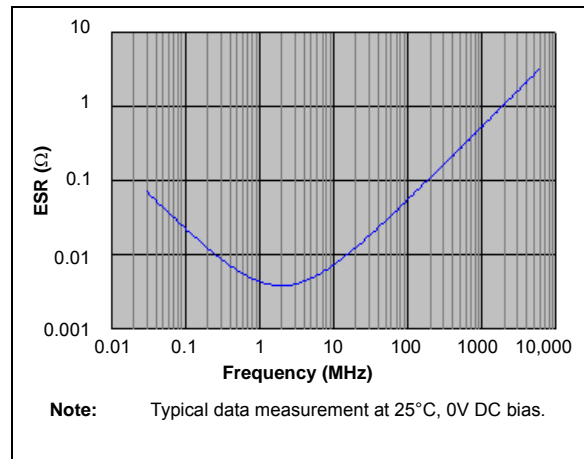
FIGURE 2-3 FREQUENCY vs. ESR PERFORMANCE FOR SUGGESTED VCAP

When the regulator is enabled, a low-ESR ($< 5\Omega$) capacitor is required on the VCAP/VDDCORE pin to stabilize the voltage regulator output voltage. The VCAP/VDDCORE pin must not be connected to VDD and must use a capacitor of 10 μF connected to ground. The type can be ceramic or tantalum. Suitable examples of capacitors are shown in [Table 2-1](#). Capacitors with equivalent specifications can be used.

Designers may use [Figure 2-3](#) to evaluate ESR equivalence of candidate devices.

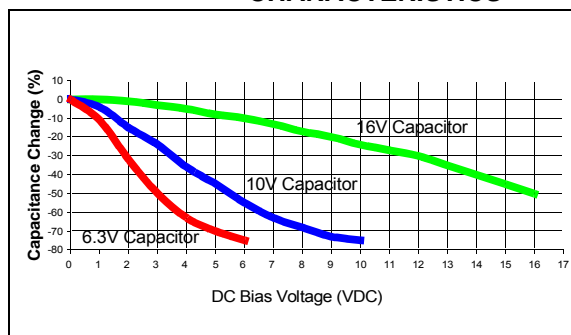
FIGURE 2-4 DC BIAS VOLTAGE vs. CAPACITANCE CHARACTERISTICS

In addition to temperature tolerance, the effective capacitance of large value ceramic capacitors can vary substantially, based on the amount of DC voltage applied to the capacitor. This effect can be very significant, but is often overlooked or is not always documented.

A typical DC bias voltage vs. capacitance graph for X7R type and Y5V type capacitors is shown in Figure 2-4.

When selecting a ceramic capacitor to be used with the VDDCORE voltage regulator, it is suggested to select a high-voltage rating, so that the operating voltage is a small percentage of the maximum rated capacitor voltage. For example, choose a ceramic capacitor rated at 16V for the 2.5V VDDCORE voltage. Suggested capacitors are shown in Table 2-1.
